Manhole Inspection Summary

Manhole # S19K1_026MH

Inspection ☐ Is Incomplete Rating: **3) Fair**

Location Address: **puget st**

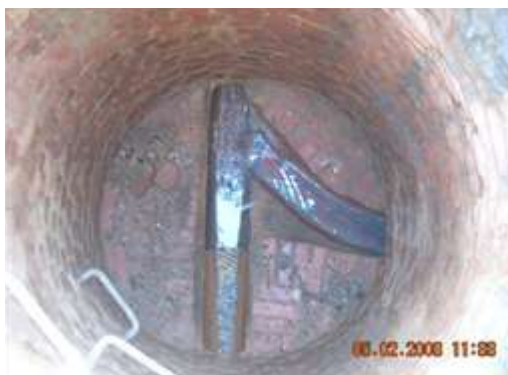
Misc

Bench Debris

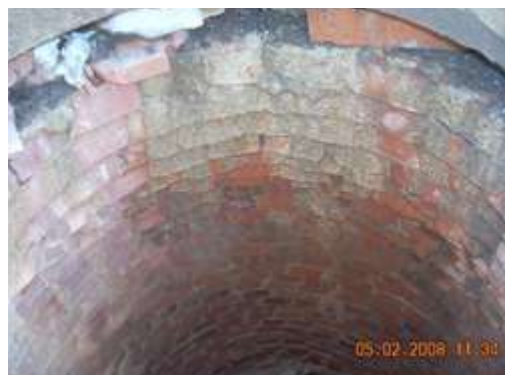
Defect 4

Infiltration: ☐ None ☒ Joint ☐ Cracks ☐ Mortar ☐ Roots ☐ Wall

infiltration @ chimney/frame joint

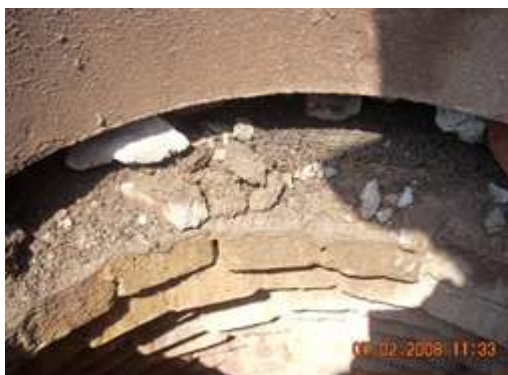
Defect 3

Condition: ☐ Sound ☐ Cracked ☐ Root Intrusion ☒ Loose Brick ☒ Deteriorated

deteriorated chimney

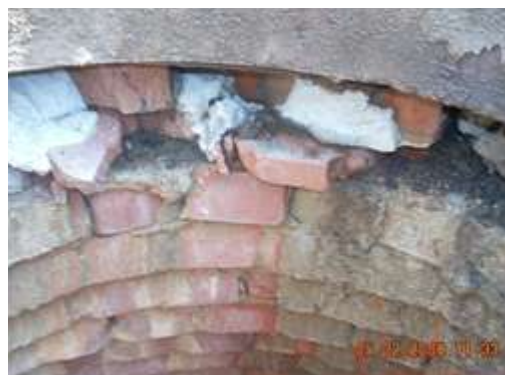
Defect 2

loose chimney bricks

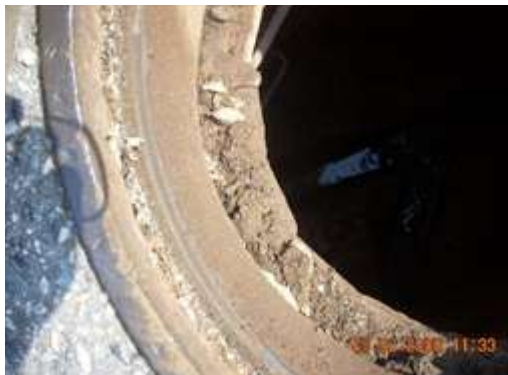
Defect 1

Offset: **2** (in.)

frame offset

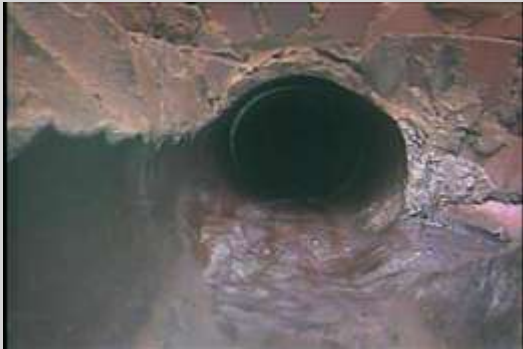
12 O'Clock Outflow

8 in. Circular Gravity Sewer
Pipe Out @ 12 O'Clock

Pipe Height: **8.4** (in.) Rod and Bar (Angled)
Pipe Material: **Clay** ☐ Pipe Lined
Invert Depth: **8.10** (ft.) Flow Characteristics: **Slow**
Deposits: ☒ None ☐ Mud ☐ Sludge ☐ Debris ☐ Grease
Silt Depth: **0** (in.) Deposits Extent:
Infiltration: **None** Pipe Seal Cond: **Cracked**
